ABSOLUTE INFRARED INSPECTION SERVICES PO Box 9594 Erie, PA 16505 814-835-9295	Thermal Diagnostics Report By: Craig Casler Level III Thermographer Level II ASNT
--	--

Customer:	XXXXXXXXXXXXXXXXXX
Date:	September 5, 2007
Location:	Parker St Sub
Equipment:	Pole HDS118
Component:	Wire Center phase Between Switch & tap
Voltage:	34,500
Amp / Load	N/A
I.D. #

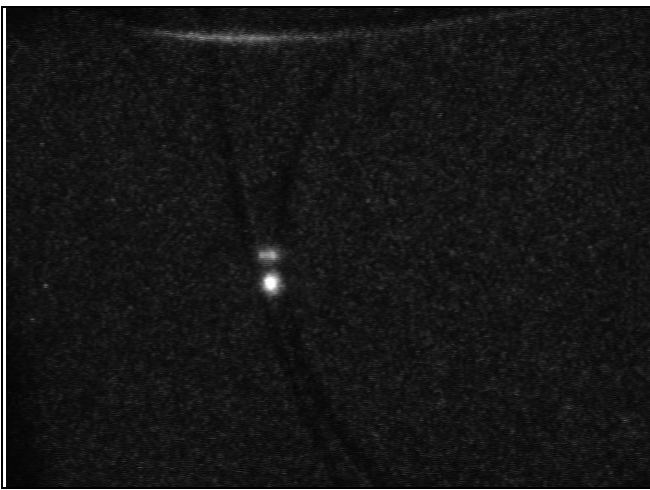
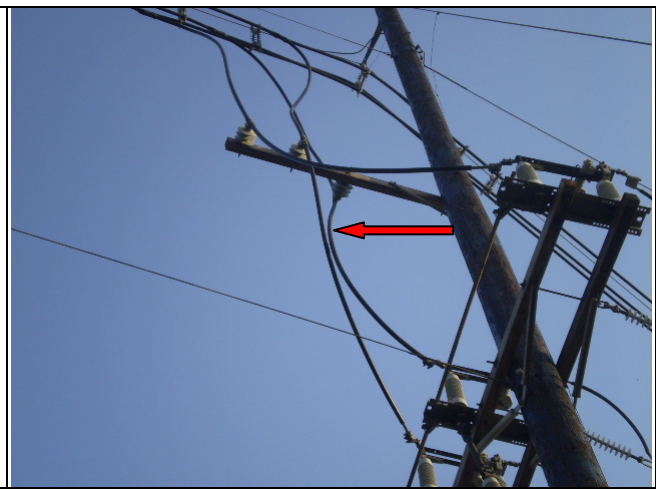
Comments: Corona was detected here. Corrective action needs taken, cleaning or replacement of damage components.

Separating these wires will likely stop the corona activity. The wires should be check for damage due to the corona activity.

A visual inspection of high voltage components will aid in catching potential problems as well. The insulation values in these components are designed for proper installation and spacing of components.
