ABSOLUTE INFRARED INSPECTION SERVICES PO Box 9594 Erie, PA 16505 814-397-3382	Thermal Diagnostics Report By: Craig Casler Level III Thermographer Level II ASNT
--	--

Customer:	XXXXXXXXXXXX
Date:	12/3/2012
Location:	Exterior
Equipment:	FGF Switch Gear /Bay #4
Component:	CT
Voltage:	34,500
Amp / Load	N/A
I.D. #

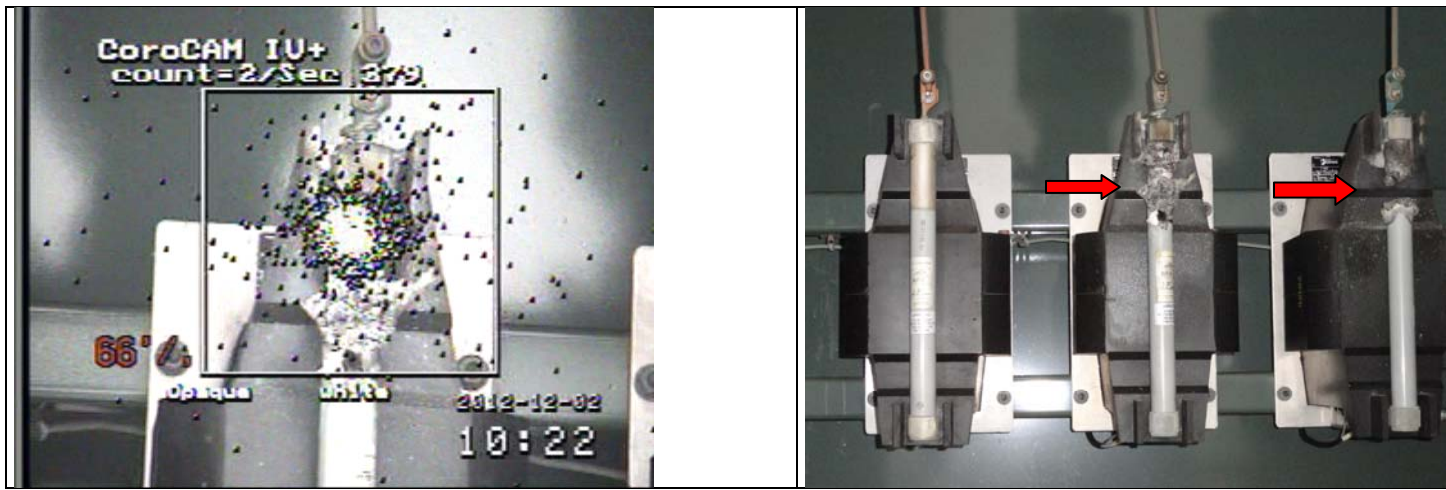
Point 1 Temperature	N/A	Ambient Temperature	48
Reference Temperature	N/A	Relative Humidity	88%
Delta Temperature	N/A	Dew Point	44
Db Point 1	44	Altim. / Pressure Hg	1,380 / 29.05
Photons	11,000+	Wind MPH	0-3 MPH

Comments: Corona was detected here. Corrective action needs taken cleaning or replacement of damage components.

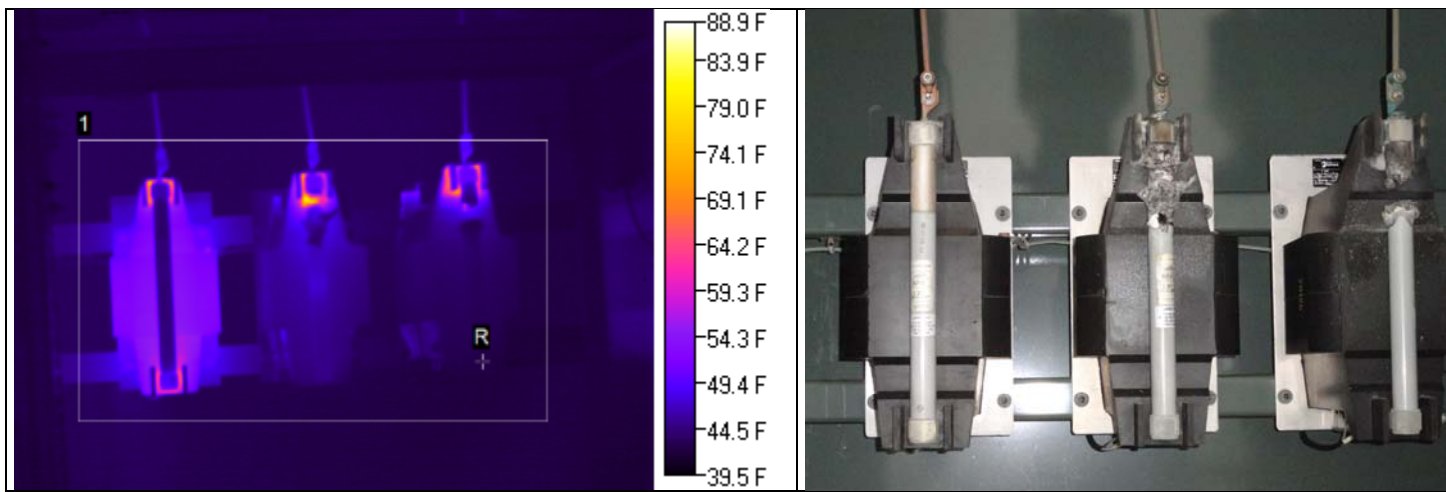
Point 1 Temperature	85	Ambient Temperature	48
Reference Temperature	49	Relative Humidity	
Delta Temperature	36	Dew Point	
Db Point 1		Altim. / Pressure Hg	
Photons		Wind MPH

Comments: Corona in advanced stages will generate heat which may not be resistance related. Arching was responsible for the heat generated in this image.

The CT on the left had not been destroyed by the corona yet but had a high amount of corona on both fuse ends.
