ABSOLUTE INFRARED INSPECTION SERVICES PO Box 9594 Erie, PA 16505 814-397-3382	Thermal Diagnostics Report By: Craig Casler Level III Thermographer Level II ASNT
--	--

Customer:	XXXXXXXXXXXX
Date:	6/18/2013
Location:	Compressor Room
Equipment:	1701 Compressor Main Cabinet
Component:	Motor Feed Wires
Voltage:	480
Amp / Load	A - 467, B - 200, C - 217
I.D. #

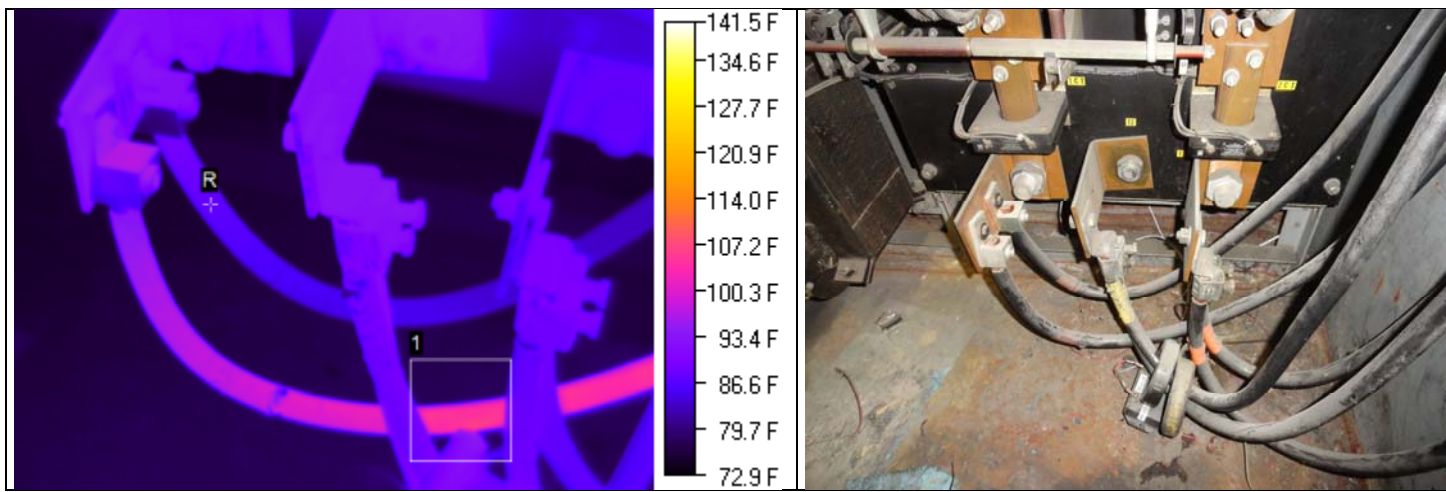
Point 1 Temperature	107	Ambient Temperature	76
Reference Temperature	88	Relative Humidity	
Delta Temperature	19	Dew Point	
Db Point 1		Altim. / Pressure Hg	
Photons		Wind MPH

Comments: The concentration of heat in this image along with amperage readings indicated a potential problem with this motor. Further investigation showed a wire was burned off transferring the load to one wire instead of two.

A repair was made and re inspection showed temps and amperage readings are back to normal. See attached photo of burnt connector.
